**1101 E. 10th Street #B
Austin TX 78703**

**Client(s): Chambers
Inspection Date: 2/6/2012**

PROPERTY INSPECTION REPORT

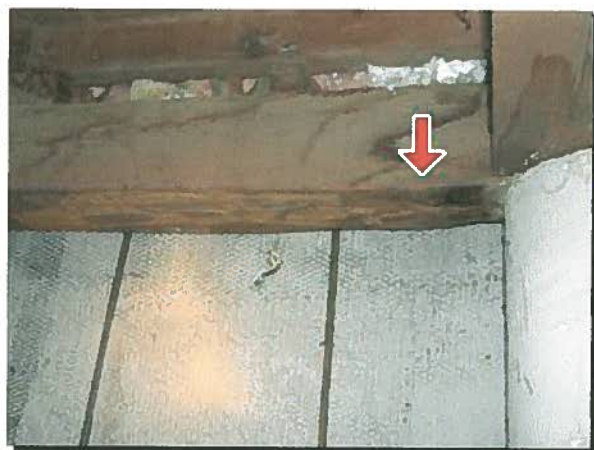
A. Picture 5

☒ Multiple areas observed below the house with various degrees of damage from water and/or wood destroying insects. The outer perimeter beam is deteriorated in multiple areas (rot and termite), most notably along the east wall. The sill plates for the wall studs are damaged from rot and termites. There is a high likelihood that upon removal of the exterior wall coverings, unseen damage to the interior wall structure (studs) will be uncovered.

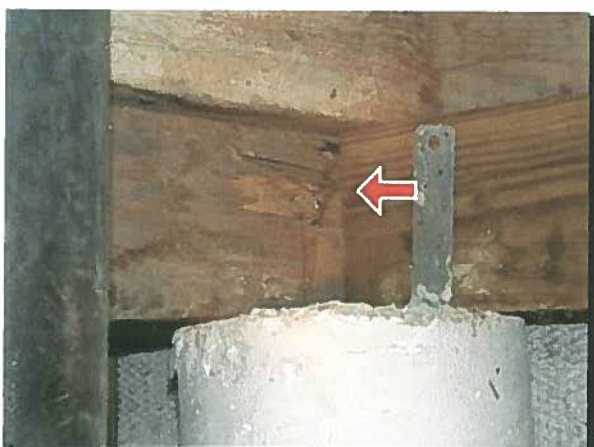
A. Picture 7

☒ Beams are not bearing fully on pilings in at least 8 areas.

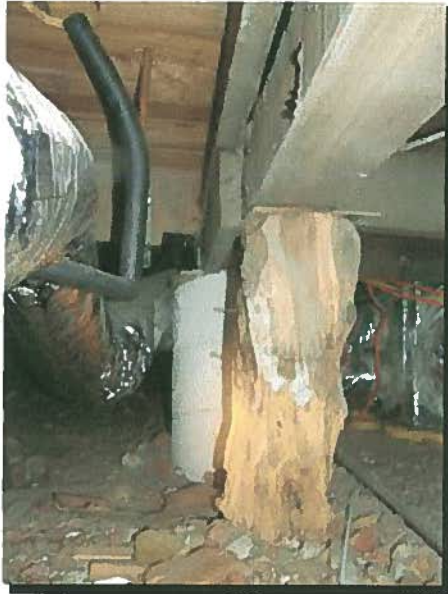
A. Picture 9

☒ Skirting is supported by wooden members placed directly into soil. Wood to ground contact is conducive to rot and infestation of wood destroying insects. Masonry support is best for this application.

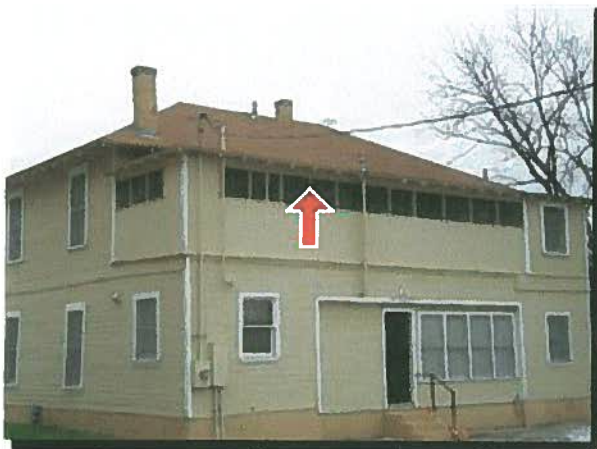
C. Picture 1

☒ The flat roof (Less than 3/12 slope) at the rear of home, covered porch has improper style roof covering (three-tab shingles). It should have either selvage, roll roofing, rubber membrane or an approved covering for a flat roof. The roof has evidence that it has been leaking (water damage and stains on ceilings).

The existing roof is improperly flashed against the wall, under the eaves of the main house.

It is recommended that the roof from the main house be extended outward over the patio area to provide a continual drain slope towards the exterior of the structure. This will entail re-constructing the outer walls of the enclosure to conform with standard requirements for load bearing perimeter walls.

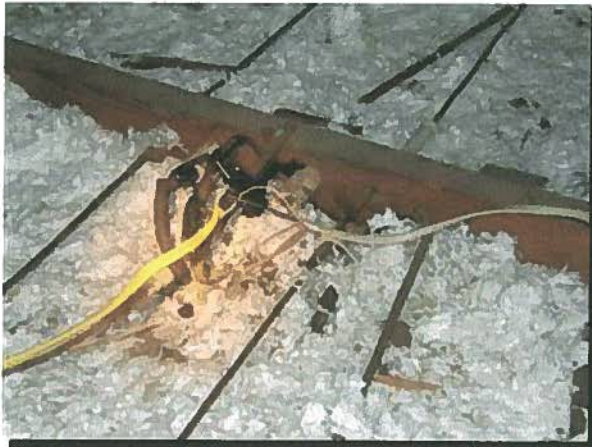
D. Picture 1

☒ Electric splices are not properly clamped or secured in junction boxes in various locations in the attic. There is knob and tube wiring present in the attic that has been spliced into. There are several areas that are safety/fire hazards and should be repaired and/or upgraded to current NEC (National Electric Code) standards. No additional insulation should be installed until branch circuitry in the attic is brought up to code.

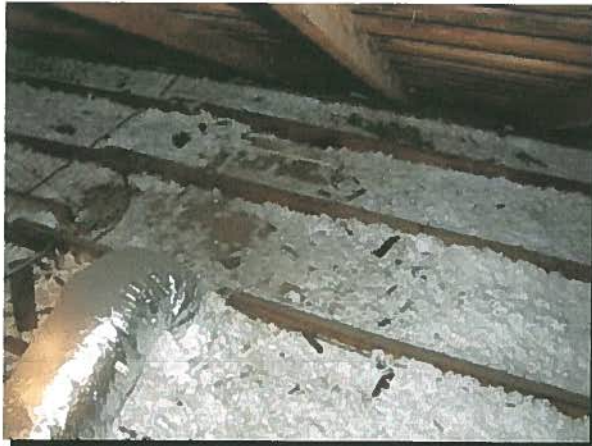
D. Picture 7

☐ Attic ventilation deficient by current standards. 1 sqft ventilation through roof per 150sqft attic space required. Recommend additional ventilation.

☒ Insulation deficient. Insulation should be installed to R-38 (14-16 inches blown, loose fill).

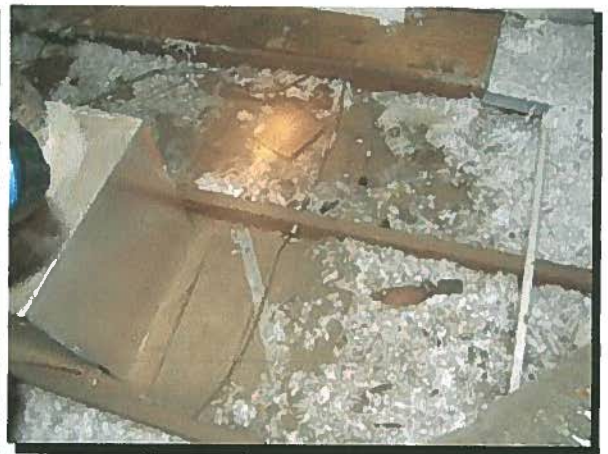
D. Picture 8

☒ Penetrations through to exterior should be sealed, pest barriers to be installed to prevent animal entry.
Note: There are indications of past pest in the attic (compacted insulation, mouse droppings, birds nest)

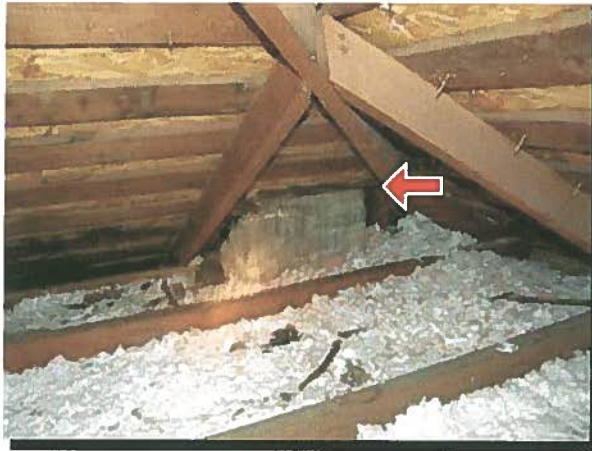
D. Picture 13

Evidence of previous water penetration at older chimney flue towards front of structure.

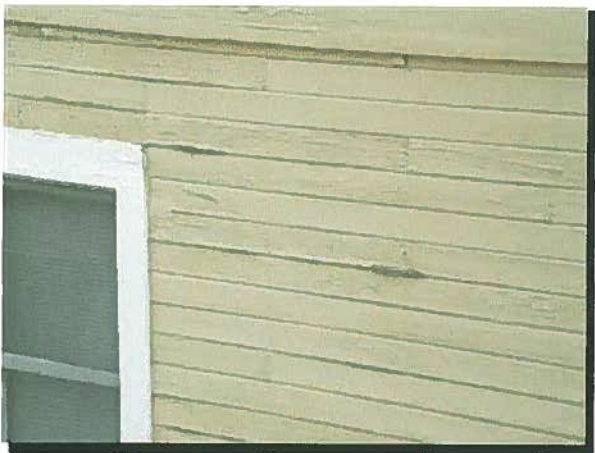
E. Picture 6

☒ There are areas of the exterior wood siding, trim, Fascia, Drip edge, door jambs, etc. that have sustained varying levels of water (rot) damage and is in need of repair

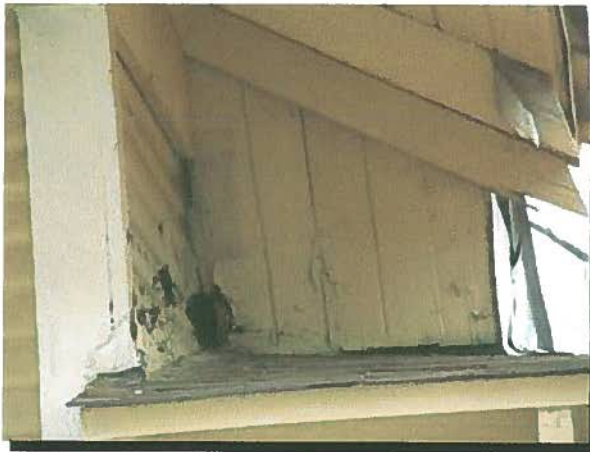
E. Picture 9

- ☒ All exterior siding butt & transitional joints that have separated more than 1/8" should be re-sealed (caulk and paint) to prevent moisture incursion
- ☒ It is recommended that all protrusions through the exterior siding and fixtures mounted on the exterior be sealed in order to prevent moisture incursion. Using a quality exterior caulk type sealant around pipes, wires, light fixtures etc. can prevent moisture related failure of electrical components and siding materials.
- ☒ Seal (paint) all exposed wood surfaces around the exterior of the home to include any bare wood, joints in siding and trim, etc.
- ☒ Front masonry pillar supports are open at top. These should be sealed to prevent water entry.

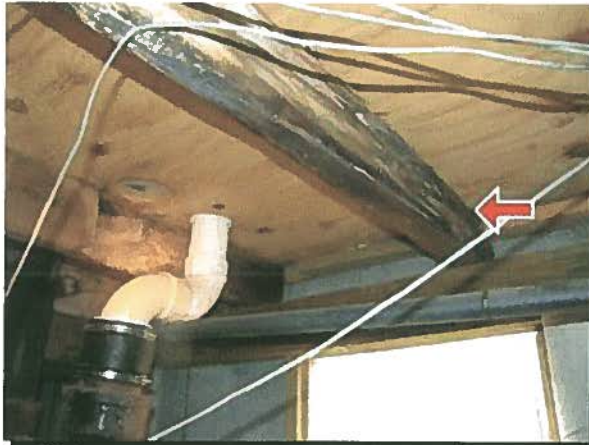
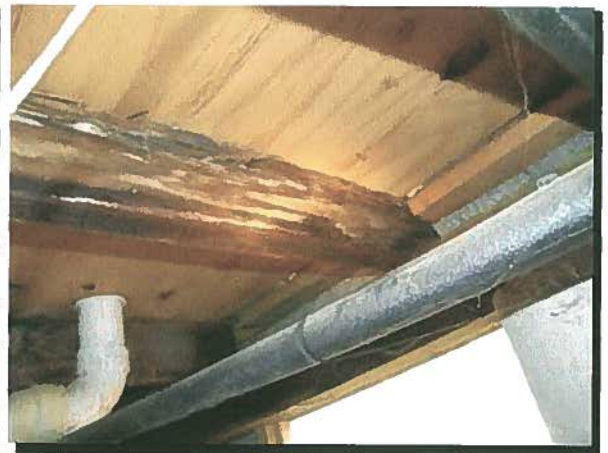
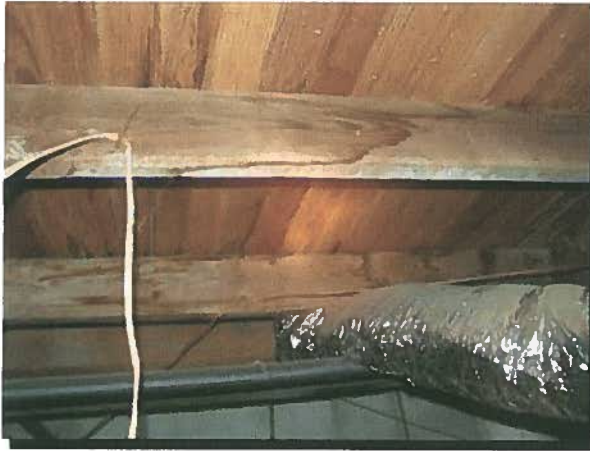
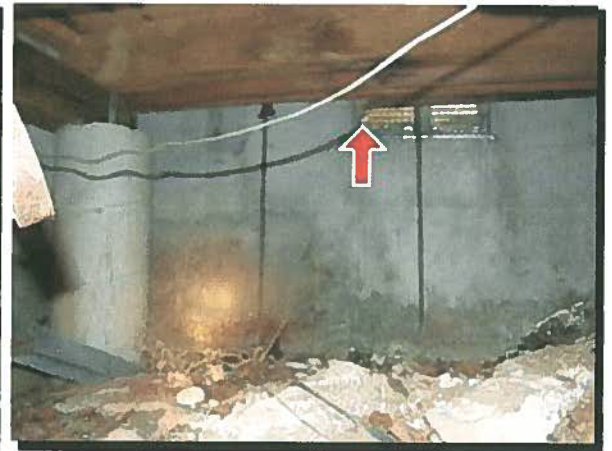
☒ Several floor joist(s) are deteriorated from moisture absorption or water intrusion under the home. Repairs are needed. Recommend a qualified engineer inspect and repair or replace as needed.

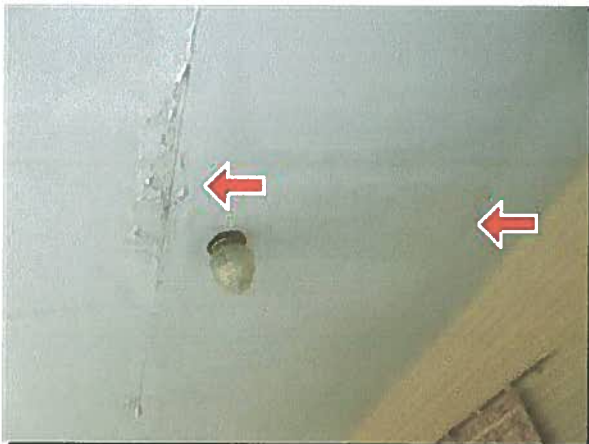
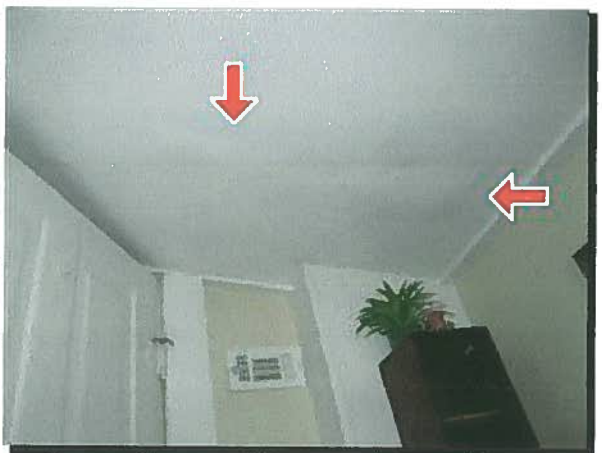
☒ Stains on ceilings in upstairs bath and patio areas indicate active leaks. Refer to roof covering section for recommendations on roof modifications.
